DSTO-TR-0372

An Electrostatic Hazards Evaluation
of RAAF Flightline Clothing

**Ship Structures and Materials Division
Aeronautical and Maritime Research Laboratory**

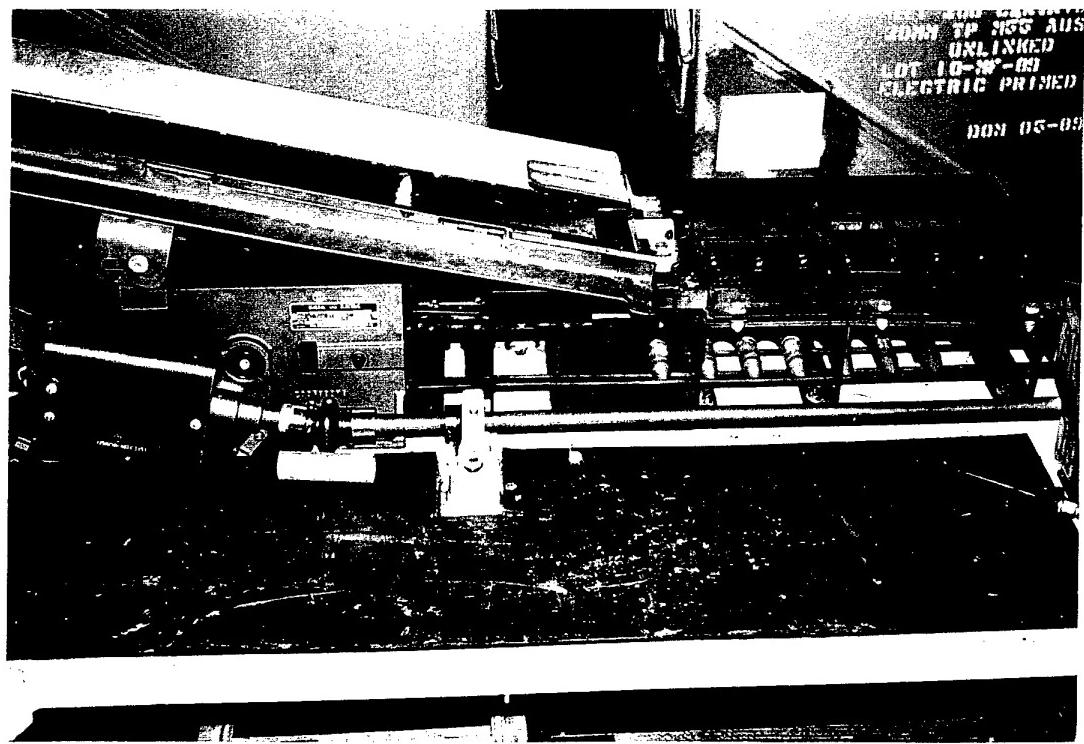
Figure 1: A replenisher assembly.

Resistance measurements (Table 13) were conducted on the replenisher assemblies to determine whether all the conducting sections were electrically bonded and that the assembly was earthed. All resistances were measured at an applied potential of 250 V and all values were low except for the drive socket and the sloping tray. These are acceptable values, however, from the point of view of electrostatic dissipation. Unless stated otherwise the assembly serial no. was 3000072.

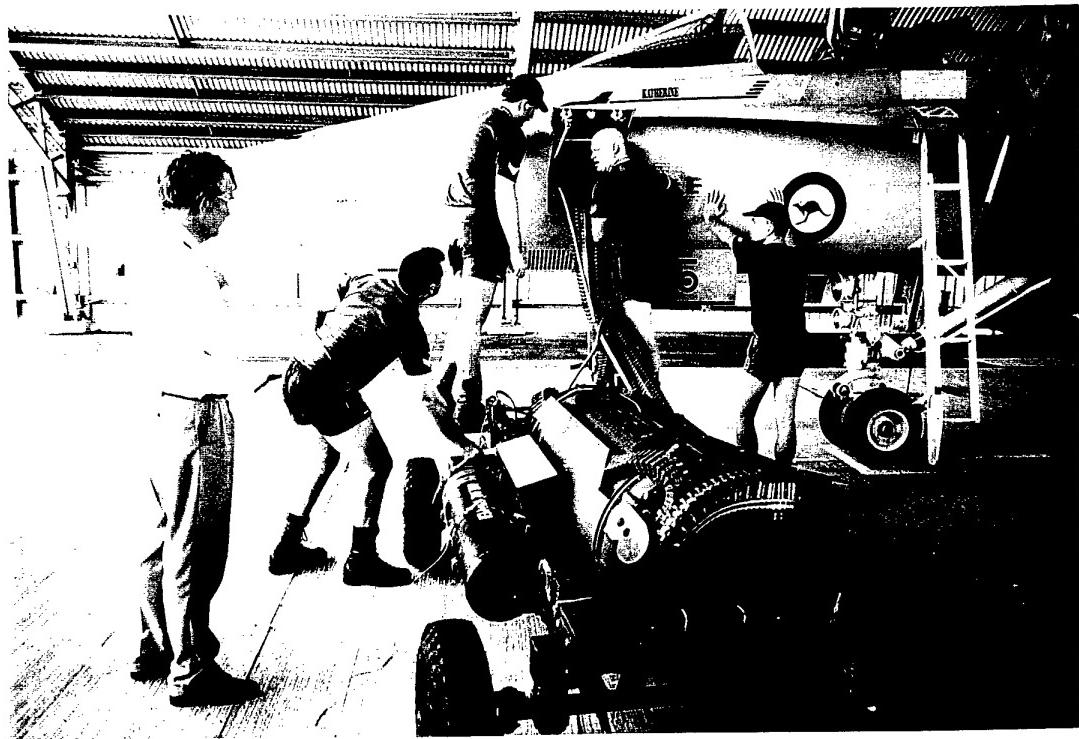
Figure 2: A loader assembly

Resistance measurements were also conducted on the loader assemblies at an applied potential of 250 V (Table 14). Wheel resistance measurements are shown in Table 15 and resistance measurements between the assembly drum and earth are presented in Table 16. Resistances are below $10^9 \Omega$ for all measurements which is acceptable for electrostatic purposes. The measurements in Table 15 were conducted with the wheel resting on a metal plate on the floor. The purpose of these measurements was to determine whether the loader assemblies provided a path to earth of sufficiently low resistance to dissipate electrostatic charge and also to determine whether the assembly components were bonded together.

- (5) It is also recommended that the metal surface of the loader platform be left in an unpainted state. If the platform has a previously painted surface then this paint should be removed before the platform is placed in service.

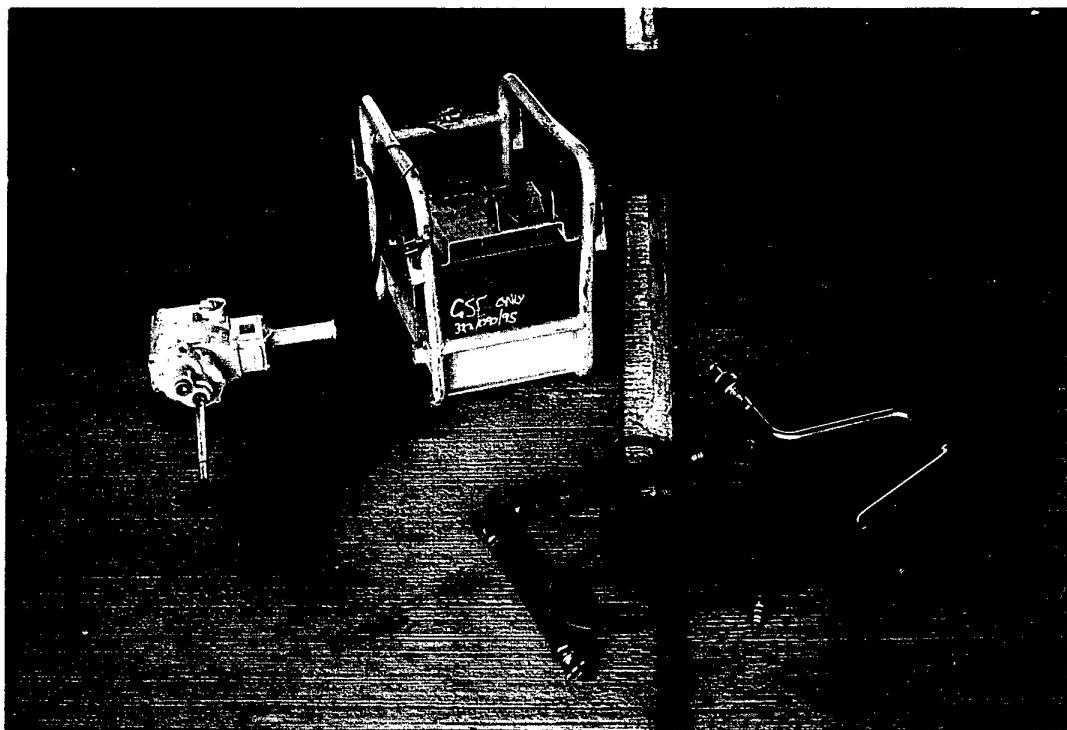
Figure 3: The three different types of loader drive unit

The electrically powered loader drive unit was tested to check whether its operation could generate a static charge. An operator wearing brown GP boots stood on a polyethylene sheet, picked up the loader drive unit and started the motor. No electrostatic potential was detected on the loader drive unit when it was operated in this way and therefore no evidence was found for the assertion that an operating electric loader drive unit could generate a static electric charge.
